Air Conditioning Rebuild

Edward F. Sowell

1976 Jaguar XJ-S

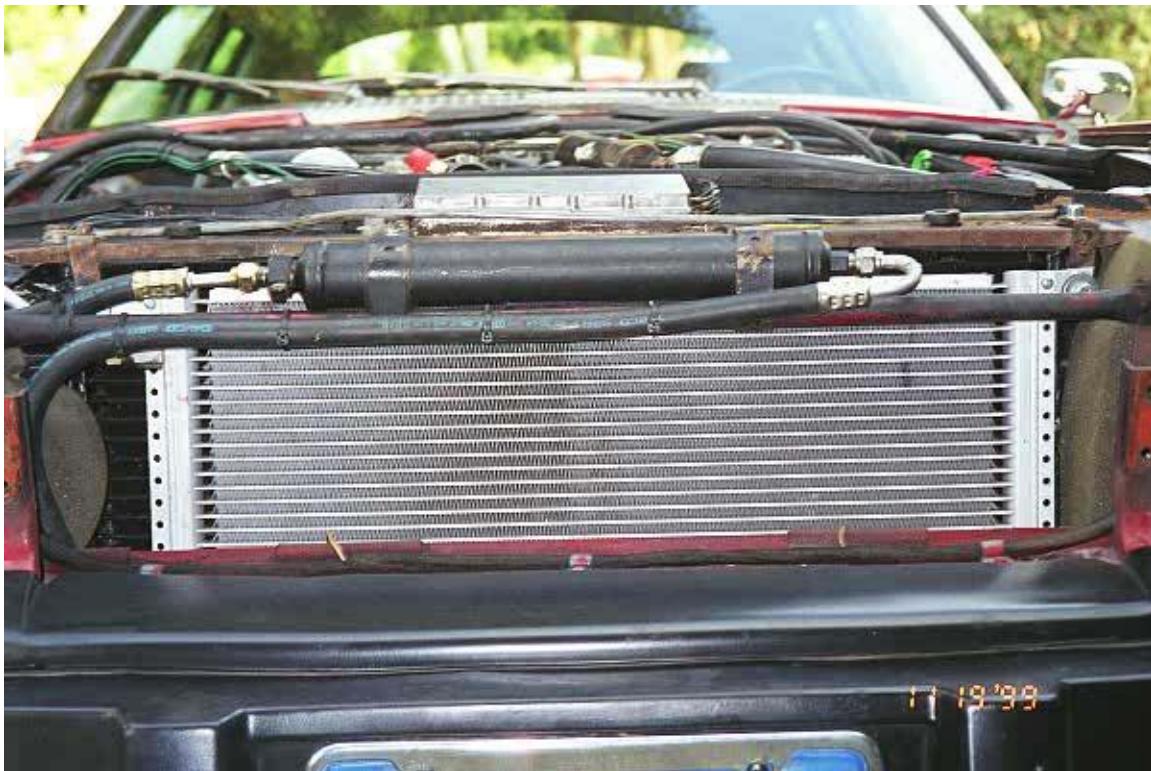
You can see how I mounted the new condenser in my car in Figure 1. The inlet and outlet are on the same side, and I chose to put them at the right (left in the picture). Obviously, all the plumbing had to be redone (See Plumbing below).

Figure 1. Parallel Flow Condenser installed in 1976 XJ-S.

You can see some of the new plumbing in Figure 1. The inlet is at the top, obscured somewhat by the hose from the outlet at the bottom to the receiver/dryer. After first trying to fit a vertical style unit at the right of the condenser, I chose to use the original style horizontal receiver/dryer mounted in the original position. This allows for easier access without removal of the bonnet, and does not block air flow to the radiator or condenser.

Additionally, as you can see in Figure 1, he talked me into more hoses than I would have liked. These guys love hoses! They use standard fittings wherever possible, and when that won't work they cut up these fittings and weld them back together to get the wanted shape. You can see some of this in the U-fitting seen in Figure 1, which was made by welding two right angle fittings. In Figure 4 you can see a bit of the fitting that attaches to the condenser inlet. He

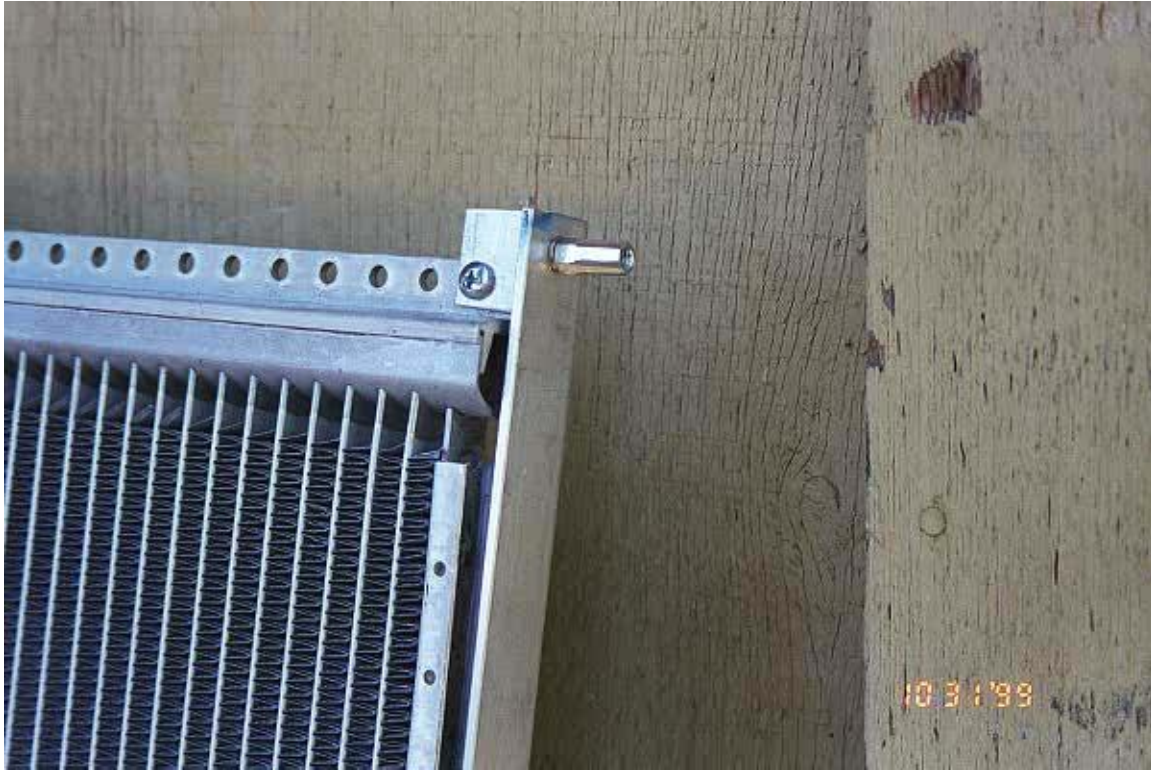
The mounting relies heavily on the original design. I attached a flat strip of 1" by 1/8" aluminum alloy stock across the bottom of the condenser, fastening it to the mounting flange that is integral with the condenser headers. This strip provides a place for the register pins that secure the bottom of the condenser to the oil cooler, just like the original design. Figure 2 shows this detail at the left side of the condenser. The pins are fashioned from 10-24 "long nuts" used to join threaded stock, available from a local hardware store. Counter-sunk screws from the top of the strip hold the pins to the mounting strip. I filed the crown edges of the long nuts, rounding them a bit, to make them fit easily into the standard Jaguar rubber grommets. This allows the new condenser to register on the top of the oil cooler exactly like the original. You can also see in Figure 2 the angle bracket, made from 1/16" x 3/4" x 3/4" aluminum alloy angle stock, that secures bottom strip to the header flange. The angle bracket is held to the bottom strip by the same countersunk flat head screw that holds the register pin.

Figure 2. Bottom mounting strip with register pins.

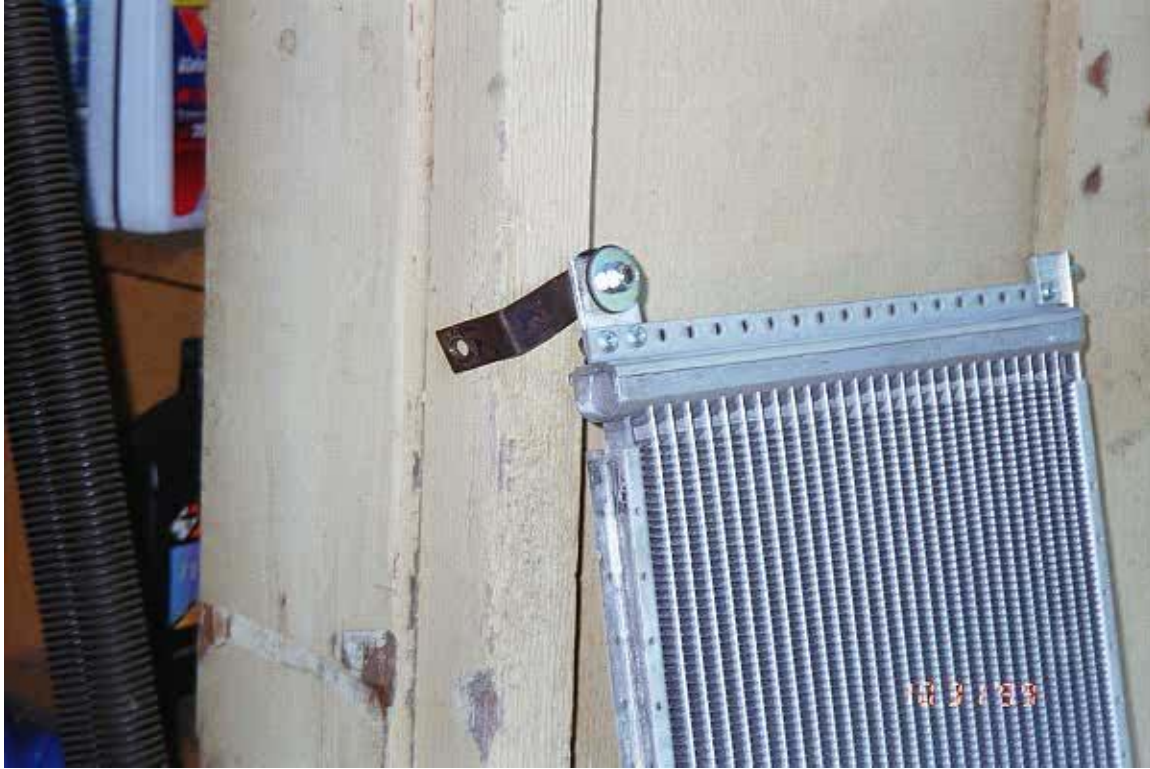
The top mounting employs the angle brackets that held the original condenser at the top. The unmodified left side bracket was attached to a tab fabricated from the 1" x 1/8" aluminum strip stock and screwed to the condenser mounting flange, Figure 3. I fashioned a grommet of sorts with a rubber washer on each side and a very short length of plastic tubing around the screw as it passes through the mounting tab.

Figure 3. Left top mounting bracket attached to mounting tab.

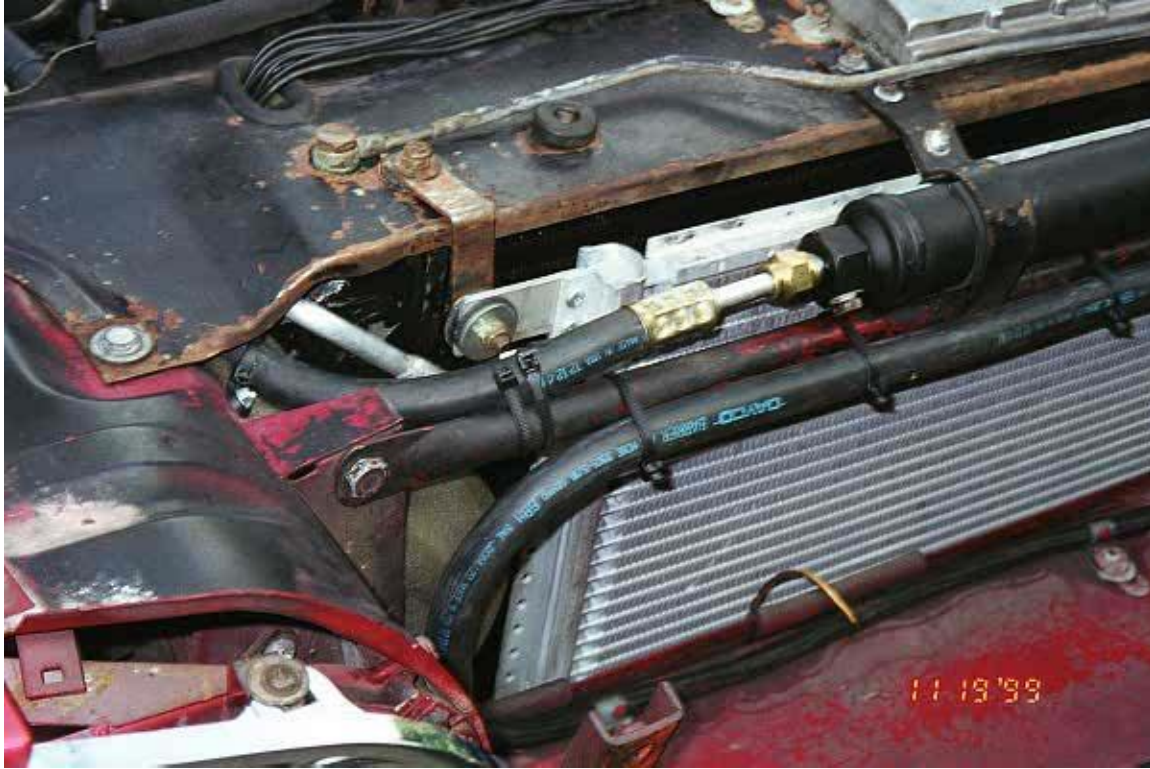
The top right mounting offered a greater challenge since, due to the offset of the condenser to the left of the vehicle, the condenser mounting flange is several inches inboard from where the stock mounting bracket attaches to the radiator cross bar. The detail can be seen in Figure 4.

Figure 4. Right top mounting.

First, the mounting tab had to be somewhat longer, as can be seen in the picture. Moreover, in order to allow good access to the refrigerant inlet hose fitting, the bottom of the tab has to be notched, reducing the width of the tab by an $\frac{1}{8}$ " or so up to the header flange. (You can't use narrower stock because it has to be at least an inch in order to allow attachment to the header flange with two screws.) Then, the stock angle bracket for attachment to the radiator top rail had to be modified significantly. I first straightened it in a vice and pounded it flat with a hammer. Then I rebent it at an angle that would bring it to a point where it could mate with the mounting tab on the condenser. Actually, it took several tries of straightening and rebending, but fortunately it is quite malleable, so it wasn't as difficult as it sounds. Then I had to cut off about an inch of its length and drill a new hole. As can be seen, it worked out quite well. But this is not something you would want to pay your mechanic \$65 per hour to do!

One final note. As you can see in Figure 4, there is about 3-4" of space at the right side (left in picture) of the condenser. It should not be blocked because there is radiator frontal area behind it. On the other hand, common wisdom is that we should carefully seal the space around the condenser, oil cooler, and radiator to keep the air going where it is supposed to go. The worry here is that the condenser air, or at least some of it, will take the easy path, rolling off the face of the condenser rather than trying to push through all those fins.

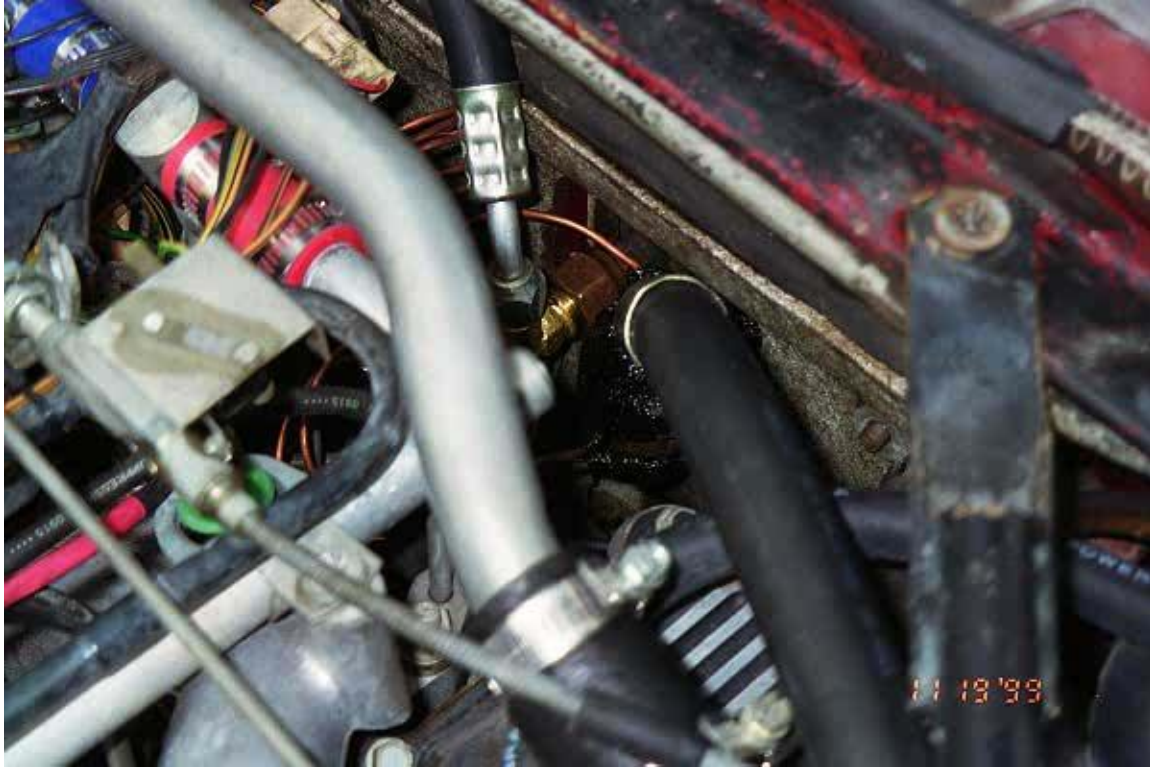
Some parts stores tell you that R-134a expansion valves are the same as for R-12. Nonetheless, AAPAK (Phoenix) sells valves with R-134a stamped on the body, so somebody must think otherwise. I believe that these valves should be sized a little differently, as the properties are a little different. On the other hand, we all know that many people have successfully moved to R-134a without changing the expansion valve, so the difference is probably slight. I feel more comfortable knowing that I have the "right" one in there.

Figure 6. New expansion valve in place (center).
