Rust Damage Due to Rear Window Seal

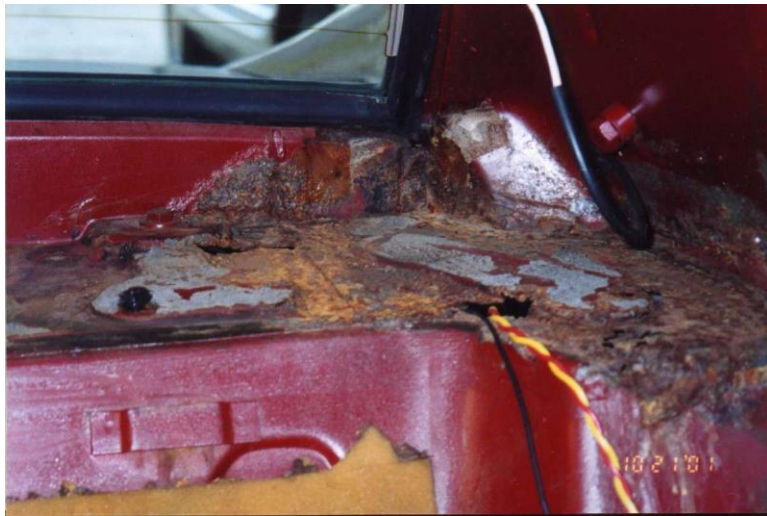
Figure 1 Left Parcel Shelf

The rear window seal was replaced when the car was repainted in 1988. Unfortunately, the glass tech didn't know how to do the job right (see Rear Window Seal Replacement). The Circuit City tech installing a new antenna in the mid 1990s must have known about the problem since he took advantage of the rust hole in the parcel shelf to run his wires, but he said nothing. By the time I discovered the leakage in 2001 it had done extensive damage to the parcel shelf and the rear floor pans. It cost over \$1,000 to fix the damage (see photos). The message is be constantly watchful for leakage around all window seals.
