# Cleaning AC Condensate Drains

*1976 XJ-S*

*September 12, 2005*

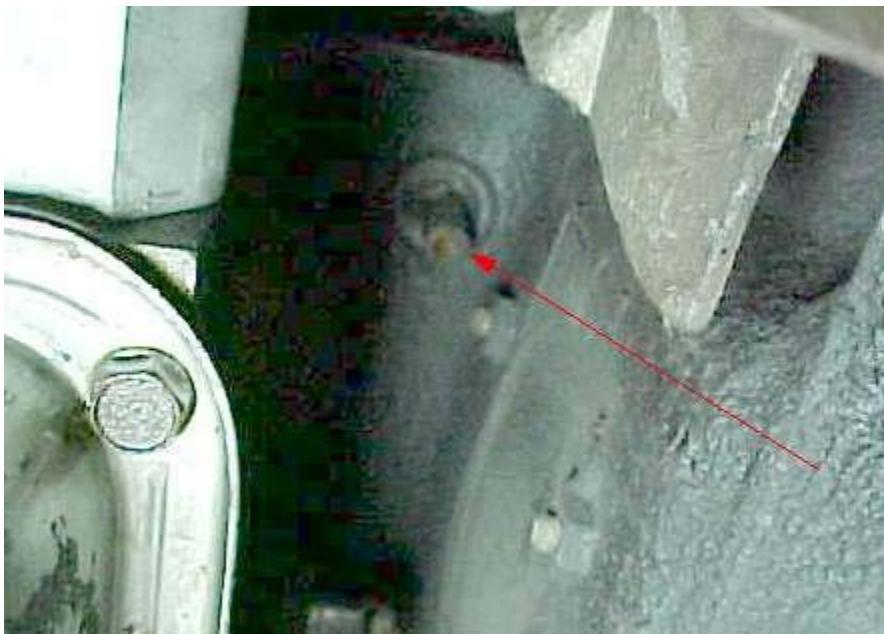
**Figure 1 Condensate Drain**

There is a drain tube on each side, dropping down from of the AC unit and emerging under the car. The red arrow in Figure 1 points to the emerging tube on the left side of the car, approximately at the front of the transmission pan. There is another one on the right side. All you have to do is run something up the tube to break loose whatever is clogging it.

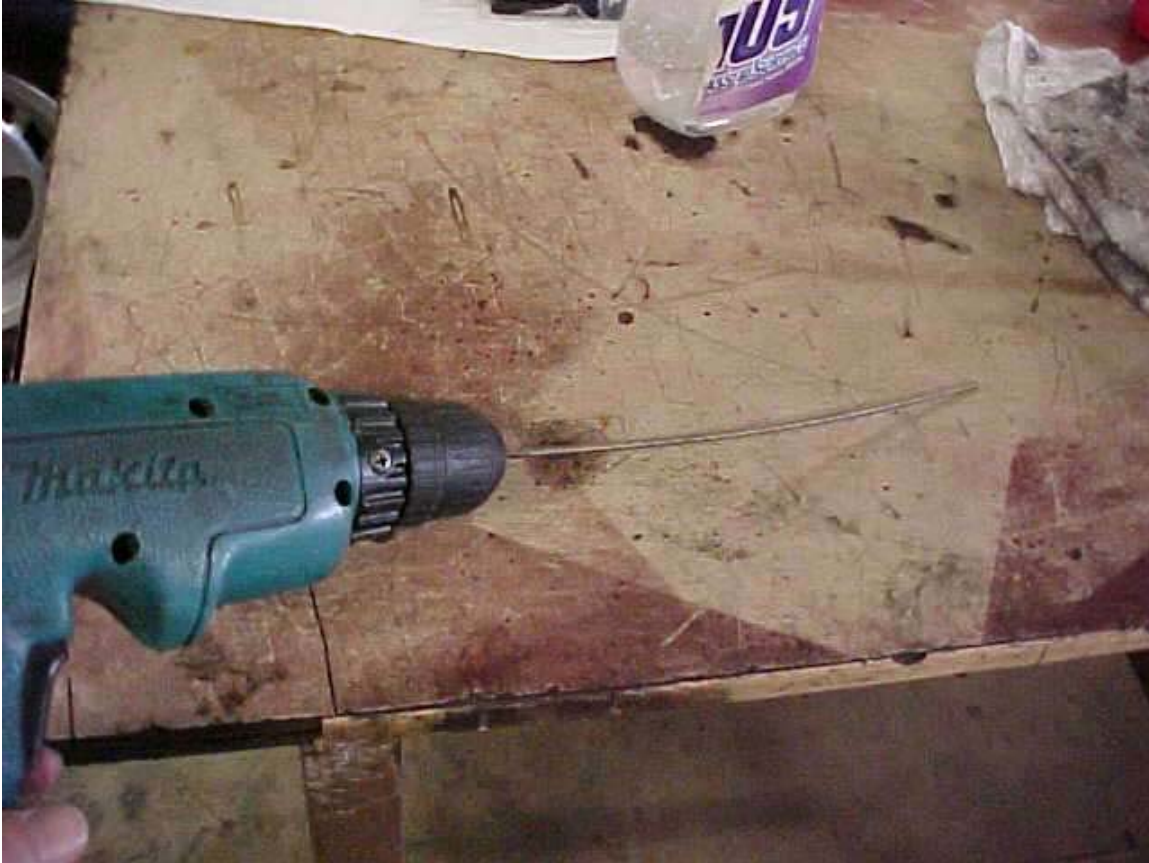
**Figure 2 Special cleaning equipment**

let me clean the tubes while it was in the air. Although most people on the XJ-S Lovers mail list seem to use a coat hanger, they let me use their “special equipment” for the job, Figure 2. In the chuck of the hand drill is a length of spiral-wound cable. It seemed to be a little more substantial, but I imagine an old speedometer cable would do the job. Or, just straighten a coat hanger like most of the folks. Either way, a gentle touch is called for because the tubes are rubber. You might want to be sure there no sharp edges on whatever you use for the job.
